# Manhole Inspection Summary

Manhole # S17YY\_013MH

Insp Date: **3/2/07 11:50 AM**

**Location** Address: **2440 DRUID PARK DR**

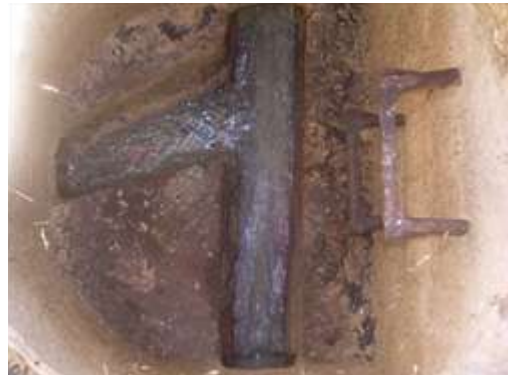
Top View

Infiltration: ☐ None ☐ Joint ☐ Cracks ☐ Mortar ☐ Roots ☒ **Wall**

☒ **Debris** (not Condition related)

Barrel infiltration. Bench debris.

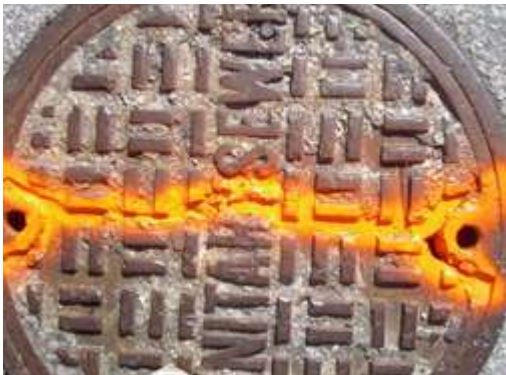
Defect

Comments **Cracked lid - unable top open 1st visit. OPENED AND INSPECTED 5/7**

Condition: **Cracked**

Cracked lid.

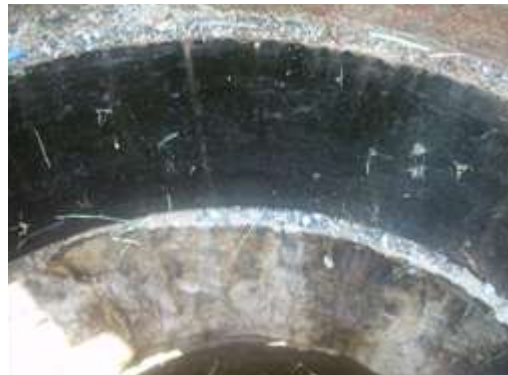
Defect

Infiltration: ☐ None ☒ **Joint** ☐ Cracks ☐ Mortar ☐ Roots ☐ Wall

Adjustment infiltration.

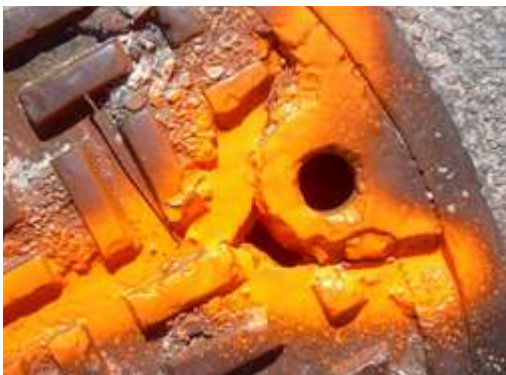
Defect

Cracked lid - close up.

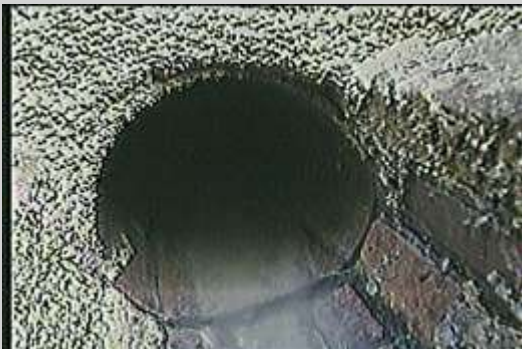
### 10 in. Circular Gravity Sewer Pipe In @ 6 O'Clock

Infiltration: **Evidence** Pipe Seal Cond: **Unknown**
